# Manhole Inspection Summary

Manhole # S29II\_004MH

Insp Date: **1/2/07 3:08 PM**

**Location** Address: **1534 MCMECHEN ST**

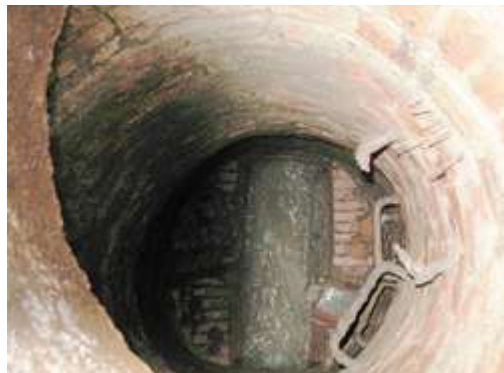
Top View

Barrel infiltration. Evidence of surcharge - Bench debris. Corroded and missing steps.

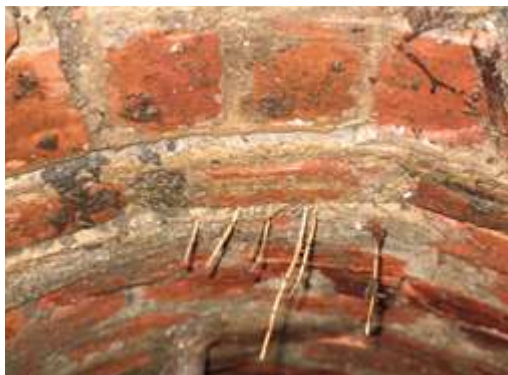
Defect

Corbel root intrusion and infiltration.

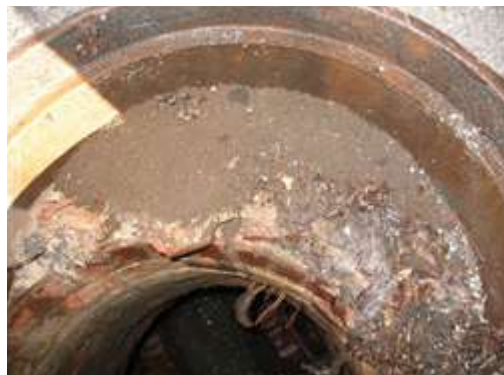
Defect

Frame leaks. Frame offset. Adjustment root intrusion and infiltration.

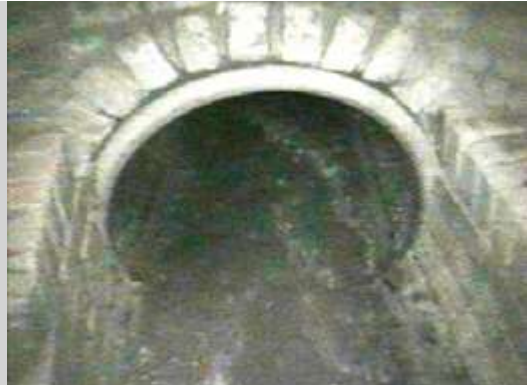
### 20 in. Circular Gravity Sewer Pipe Out @ 12 O'Clock

Invert Depth: **11.97** (ft.) Flow Characteristics: **Fast**

Infiltration: **Evidence** Pipe Seal Cond: **Unknown**

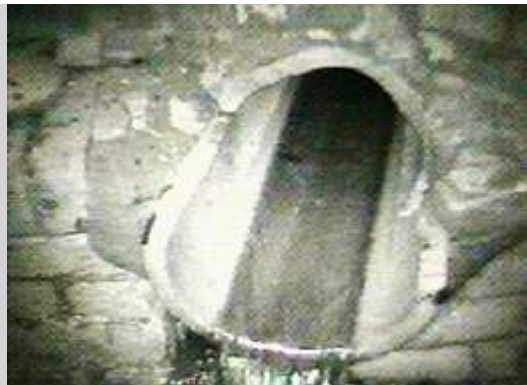
### 8 in. Circular Gravity Sewer Pipe In @ 4 O'Clock

Invert Depth: **11.25** (ft.) Flow Characteristics: **Slow**

Infiltration: **None** Pipe Seal Cond: **Unknown**

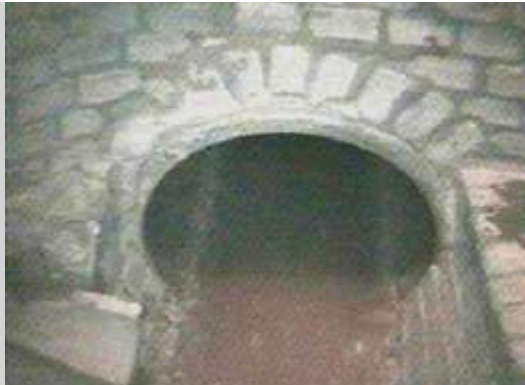
### 21 in. Circular Gravity Sewer

Deposits: ☐ None ☐ Mud ☐ Sludge ☐ Debris ☒ Grease

Deposits Extent: **Light**

Infiltration: **Evidence**

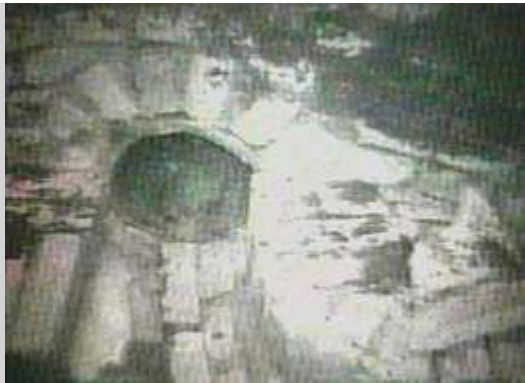
### 10 in. Circular Gravity Sewer

Invert Depth: **10.93** (ft.) Flow Characteristics: **None**

Infiltration: **Evidence**

Connects To: **Dead End**
